Rope design and its impact on damage tolerance of deepwater mooring lines

Author: L. Hoppe
 BEXCORopes, Belgium
 E-mail: lhoppe@bexco.be

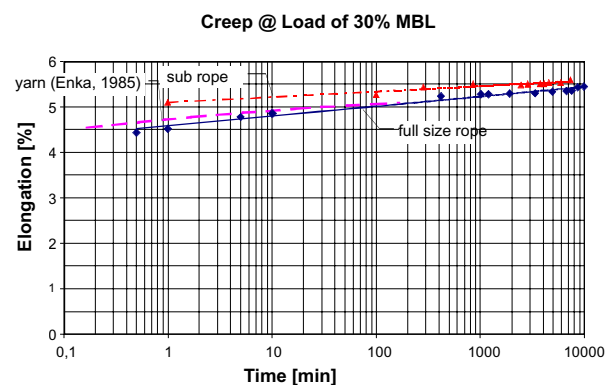
In figure 1 the creep is compared for a fibre, sub-rope and the full-size rope. Here an empirical relation is used to describe the behaviour under a continuous, static load. From the graph it can be concluded that this relation applies to the fibre, sub-rope and full-size rope. For other properties similar results are given in ref [1].

Figure 1: Creep of fibre, sub-rope and full-size rope.

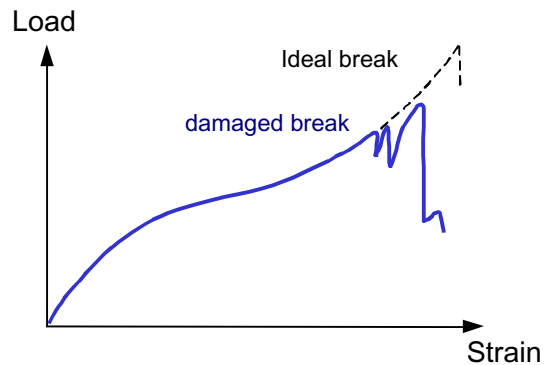
These relations can then be used to model the behaviour of the rope. The effect of changes in the rope can be predicted using the appropriate model. This approach has also been applied in the DnV Damage Guideline, see ref [3]. In the Damage Guideline it is assumed that a damaged sub-rope will carry load until its rupture, after rupture the load is transferred from the broken sub-rope(s) to the others. With the additional load the intact cores may or may not fail, depending on the type of damage, see also figure 2 for a typical load-elongation curve of a damaged rope. This effect can be estimated using a simple spreadsheet.

Figure 2: Load-elongation of a damaged versus an intact rope.

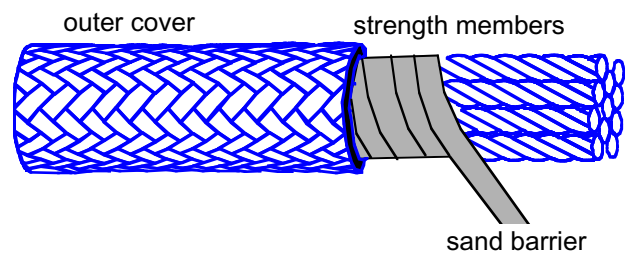
DeepRope® lines are constructed in a parallel strand construction. Each of the strands or sub-ropes consists of a three-strand rope that will be produced in both right-hand lay and left-hand lay. The lay-up of the sub-ropes is such that the finished rope will have a torque-balanced construction. The sub-ropes will be laid parallel to each other, then a sand filter is wrapped around the cores and this is then covered with a polyester braided jacket, see figure 3. The building block is a laid rope, for different sizes of finished rope the number of sub-ropes is changed, not their size. The filter prevents the ingress of soil into the rope and the cover gives the rope its shape stability and protects the cores against minor handling damage during installation.

Figure 3: DeepRope® geometry

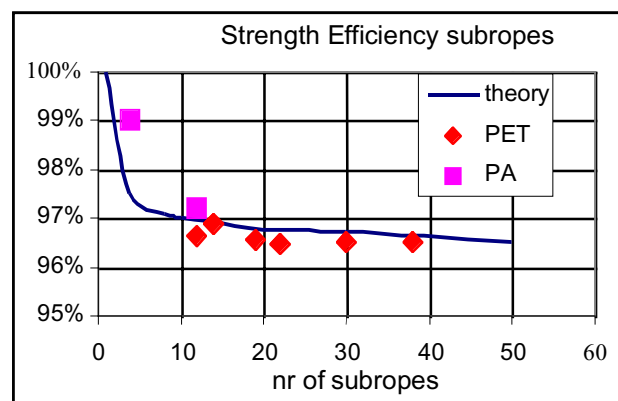
One pronounced difference between a parallel-strand rope and other, more traditional designs is the efficiency. For most rope constructions the efficiency reduces with size, however for DeepRope® lines the efficiency is independent of the size over a practical range, see also figure 4.

The initial decrease in strength can be explained by the few number of sub-ropes, the assembled strength is close to that of the single core, whereas for ten cores or more it

PET = PolyethyleneTeraftalate (polyester) PA= Polyamide

Figure 4: Strength of the DeepRope™ design.

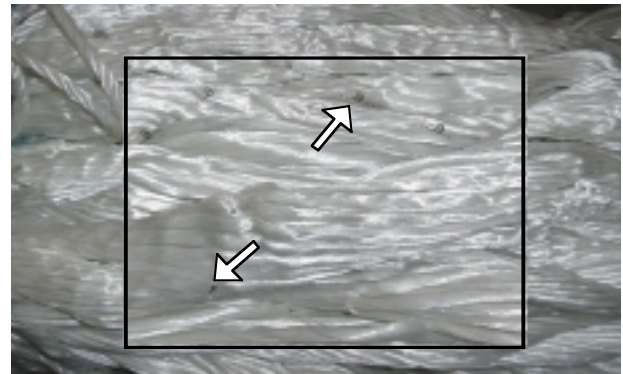
tends to be at the minimum strength. Every sub-rope is spliced into itself, making the design more damage tolerant, for this purpose every core has a special marker tape allowing easy identification, see figure 5. The technique has been developed to splice with minimal tools. This allows splicing on site, requiring only a few tools and a clean, dry workspace. With the more accurate splicing technique variation has reduced, giving a higher reproducibility when the ropes are tested. This has resulted in a high, consistent strength efficiency of the sub-rope in the final assembly, see figure 3. Not only strength, but also other properties can be predicted, however this will not be discussed here.

Figure 5: Detail of a DeepRope™ splice

The damage found in the rope (from figure 5) was minimal. Based on the number of damaged yarns found a residual strength has been estimated at 86% of the original.

Re-splicing would have been very difficult if the possibilities of doing it on site had not been considered when designing the splice procedure.

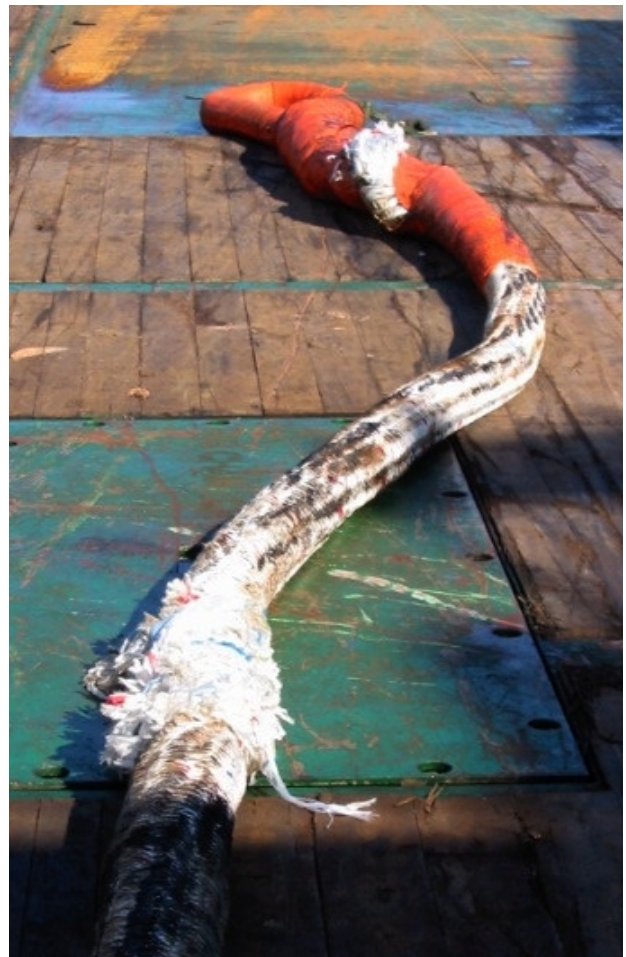
A first use of this damage assessment methodology can be for temporary moorings. For example in a drilling project (where the mooring has to be relocated every month) there is a realistic change that the mooring lines will damage in the handling. In figure 6 typical handling damage is shown.

Figure 6: Handling damage.

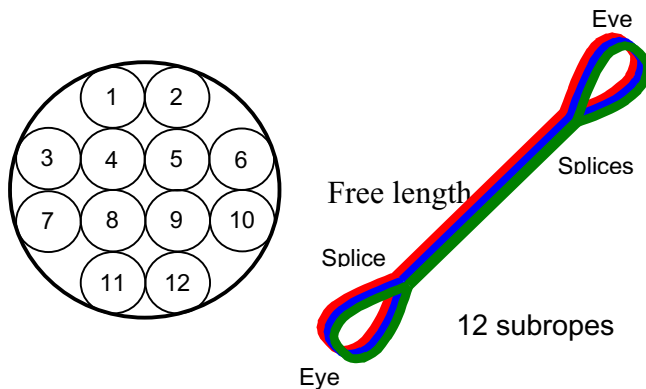
Figure 7: Typical lay-up of a mooring line (12 sub-ropes shown here)

This gives the most conservative estimate. With the type of splicing at Bexco, see figure 7, the effect is limited to one single core per damage.

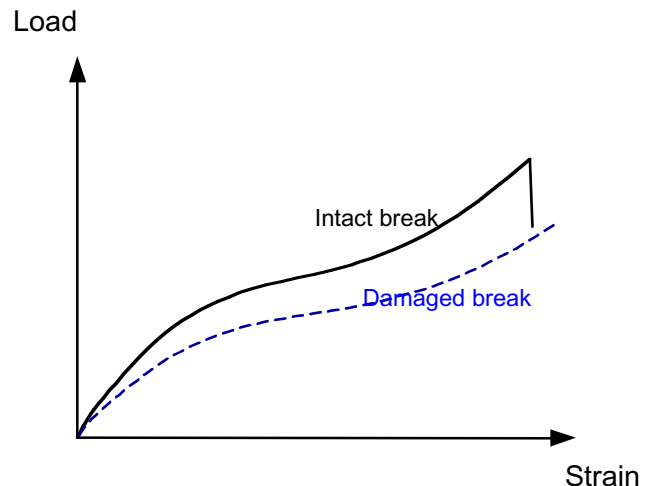
The estimate of a damaged rope is based on the strength estimate of the intact rope, the reduced strength of sub-ropes, and the number of sub-ropes. From experimental observation a local damage has two effects: firstly the load-bearing material is reduced, secondly the rope geometry changes (it unlays). This will change the load distribution, typically giving the damaged rope a slightly higher elongation. See also figure 8.

Figure 8: Load-elongation of damaged sub-rope.

The damage has to be compared to that of the intact rope, based on the manufacturer's information, see figure 8.

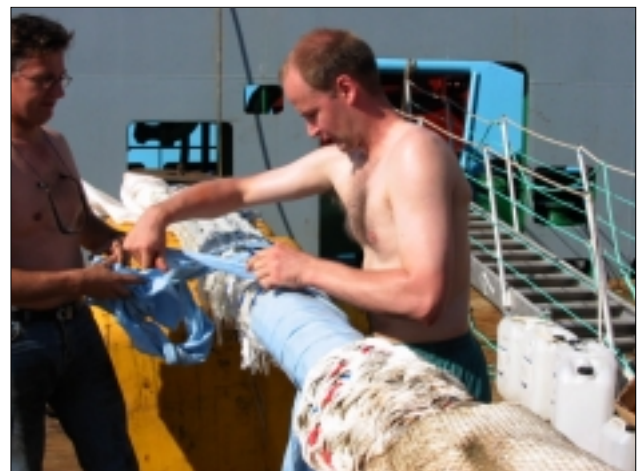
Here it was decided to re-terminate the rope, because the damage was at the extremity. This reduced the rope length by some 15 meters, however the original MBL could then be guaranteed. See also photo of re-splicing.

Figure 9: Repair almost complete.
